# TECHNICAL BULLETIN

## HN SERIES TRUCK SUSPENSION

No: 97117-118

Subject: *Bolster Spring Inspections*

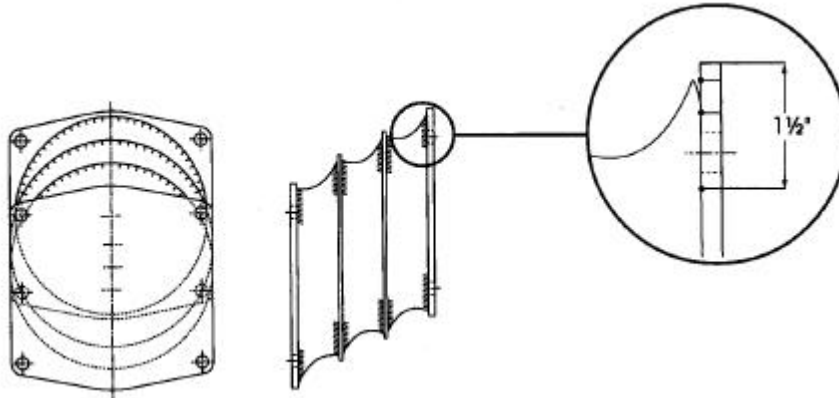
Cuts or splits of over 1" in length and of an average depth of 1" should be considered as possible points of failure.

The most probable areas of damage are shown in the picture above as "//////"

Bonding defects showing separation of the rubber from the bonded metal surface to a depth of approximately 1½" is acceptable. See picture above.

If the depth is more than 1½" the bolster spring should be replaced.
