# H TECHNICAL BULLETIN

## HT SERIES, INTRAAX TRAILER AIR SUSPENSION PIVOT CONNECTION FASTENER UPGRADE

No: TRAILER AUS - 015  
Subject: *Product Update*  
Date: July 1999 Revision: A

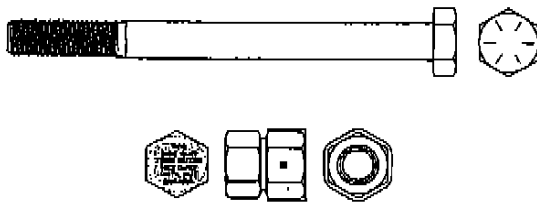
Figure 1. Existing Pivot Connection Hardware

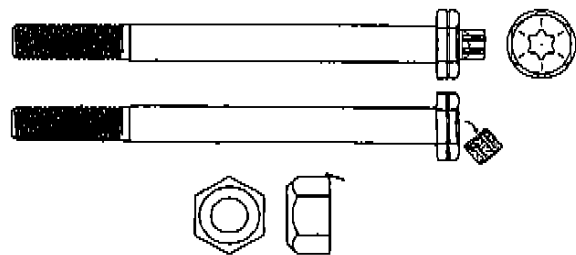
Figure 2. New Pivot Connection Hardware  
**Part No. S-24679**

Effective August, the bolt and, "TORQ-RITE" nut will be replaced with a shear-head bolt and prevailing nut. This will permit flexibility when installing the, "QUIK-ALIGN" arrangement on the suspension.

Because torque requirements vary between the existing and new pivot connection hardware, do not mix the current style with the new revision.

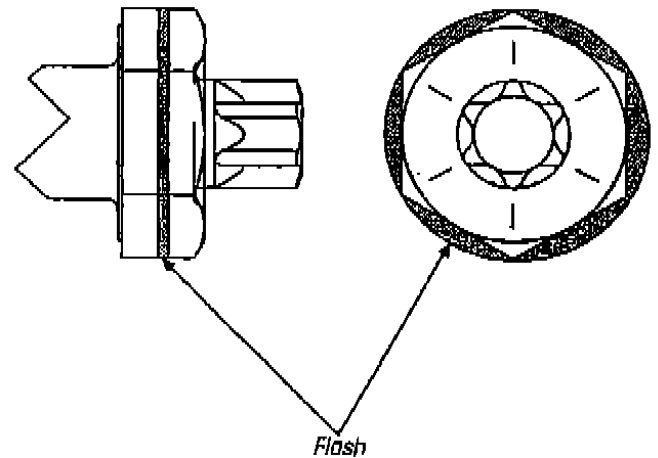
*Figure 3. Flash on the new pivot connection bolt*

To reuse the shear head bolt, the repairer must grind or chisel off the flash (the excess metal around the sides of the hex head) from the bolts head. (figure 3) To ensure proper performance and clamp load the connection must be re-tighten to a torque of 550 ft-lbs. Failure to achieve the correct clamp load may result in damage to the suspension and adjoining components.
