TECHNICAL BULLETIN

HT230 TRAILER AIR SUSPENSION LOWER SHOCK ABSORBER CLEVIS REWORK PROCEDURE

No: 49441-224 (TRAILER AUS-016)
Subject: Repair Procedure
Date: December 2001 **Revision:** A

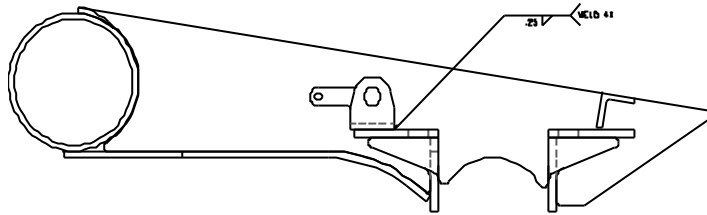
In the event of the lower shock absorber clevis becoming detached or a crack detected at the connection to the suspension trailing arm, the clevis can be effectively replaced.

Kit part number 98544-021 has been released to effect the repair. The kit contains a replacement clevis, shock bolt and reinforcement gusset block.

Where the weld retaining the original clevis has cracked, or the clevis has become detached, grind off the remaining weld and attach the new heavier clevis as per the process documented in the kit (49441-249).

It is vital that cracks or damage to the trailing arm plate are ground out and welded and the area is smooth and flat prior to the new clevis being fitted. Position the assembly as per drawing 49441-249. Ensure the reinforcement gusset (98870-004) is positioned with the chamfered edge toward the trailing arm.

Weld around the block in 1 continuous weld commencing and terminating 10mm from the existing beam weld. Bolt the clevis to the gusset block with the bolt provided. Weld the clevis to the gusset block in one continuous weld. Run a final continuous weld around the clevis and trailing arm also commencing and terminating 10mm from the existing beam weld.

Remove the bolt and fit the shock absorber. Apply Loctite 277 to the bolt and torque to 260-320 ft/lb. Clean and paint the repaired area.
